COASTAL EROSION MITIGATION AND LOW COST SEA LEVEL RISE PREPARATION IN BRAZIL

ABSTRACT

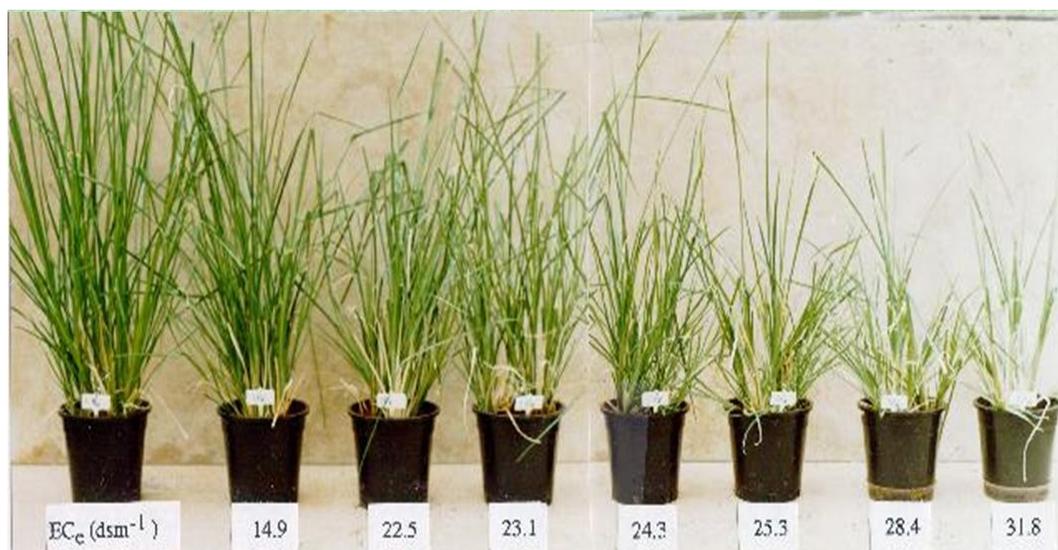
Figure 2: Vetiver tolerance to salinity.

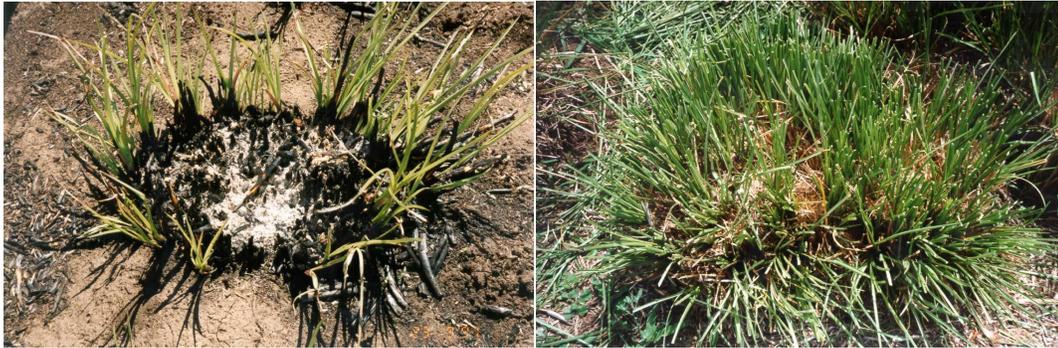
Figure 3: Vetiver tolerance to fire
Source: Paul Truong

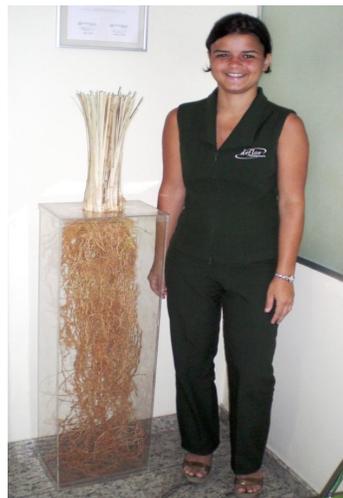
Figure 4: Roots of a young dehydrated Vetiver Grass compared to a 1.60 m tall person.
Source: Deflor bioengineering / Luiz Lucena.

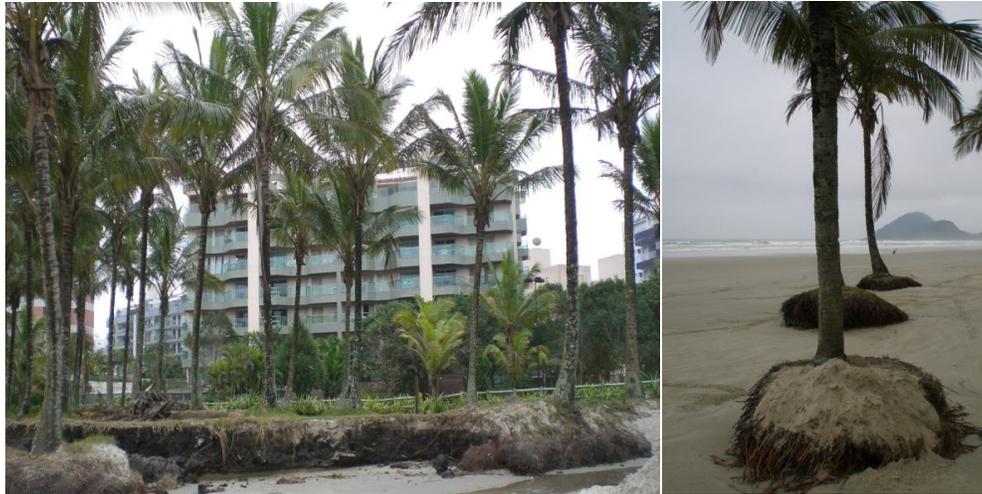
Figure 8: Coastal erosion caused by storm surges and tidal changes.
Source: Luiz Lucena.

However, this procedure was not efficient to promote soil protection and stability. During the storm surge that occurred in the years 1995 to 1997, sweet grass' root system of was not deep or resistant enough to protect soil against surf and the impact of waves during high tides, resulting in the undermining of the embankment formed by *Jundu*, as can be seen in Figure 8. Several coconut trees fell down and a severe erosion process was evidenced.

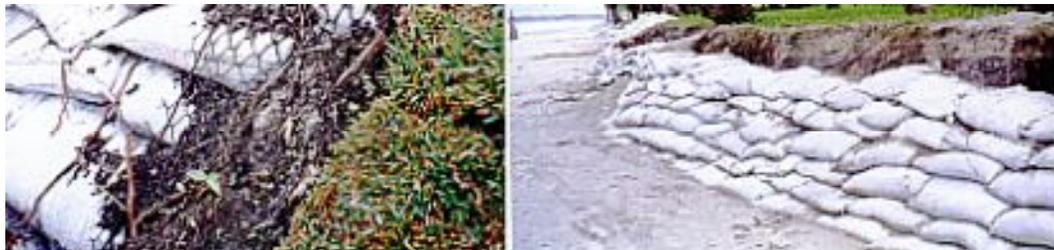
Figure 9: raffia bags to resist surf erosion.
Source: Field, J. B. N., 1998.

The initial solution set in 2008 was to build a rip rap using raffia bags previously filled with a mixture of soil-cement in the proportion of 12% cement and 88% soil extracted from the vegetation removal stage. The bags were conveniently arranged in the shape of pyramid and covered with a geogrid - high density polyethylene extruded plastic screen to minimize the effects of wave breaking and allowing the deposition of sand from the return of the waters in which the new vegetation was planted, resulting in an enhanced carpet and homogeneous surface ensuring stability, Figure 9.

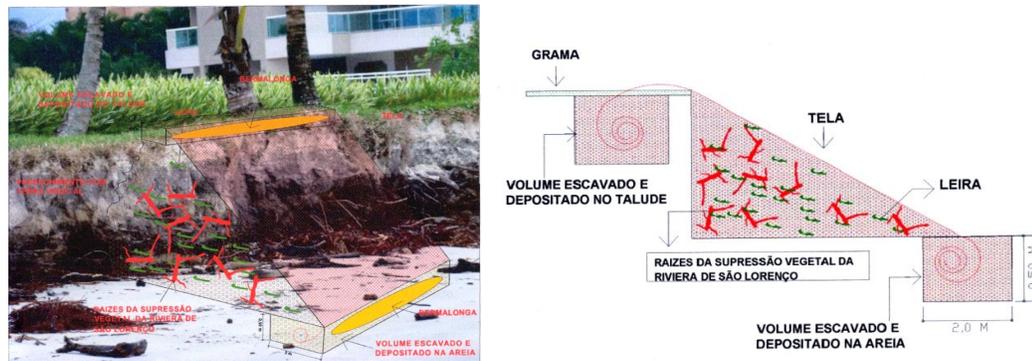
Figure 11: Schematic representation of the slopes of the project being developed.
Source: Gaia Environmental Consulting

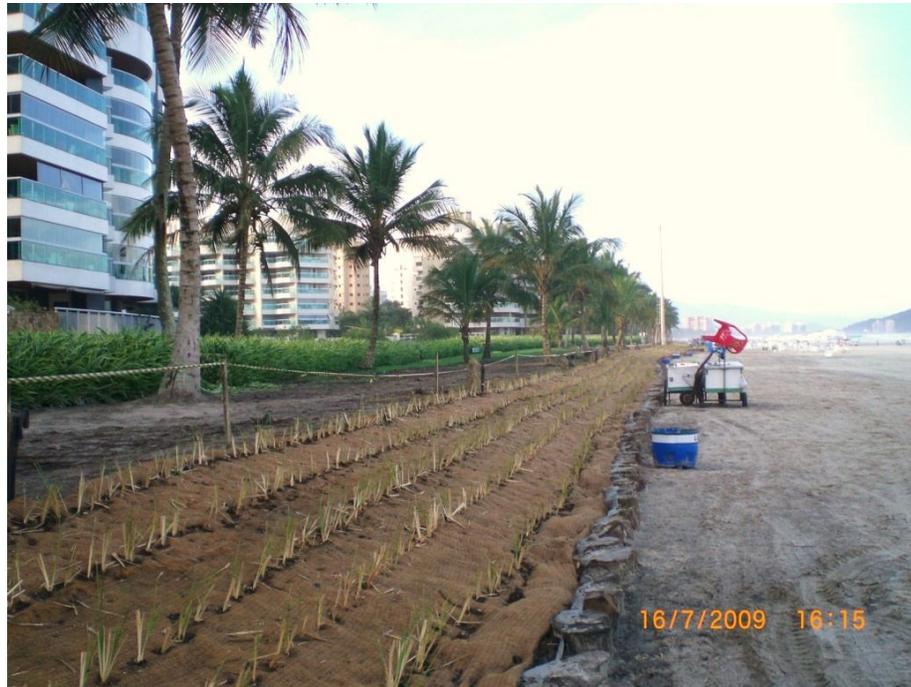
Figure 12: Final Project executed: palisade, erosion control blanket and Vetiver hedgerows.
Source: Luiz Lucena.

Due to the concern regarding to sea level rise in the near future and the need to consume logs originated from deforestation process in an environmentally friendly manner, designers decided to add a wood palisade separating the sand beach from the landscaping area in order to increase security factor of the structure. The palisade was designed to use part of the wood stored during development of the urbanization project and the slopes incorporated biomass that was also stored and had to be used within the limits of the project and could not be burned according to Brazilian environmental regulations (DPRN Authorization No. 29/2005). Figure 12.

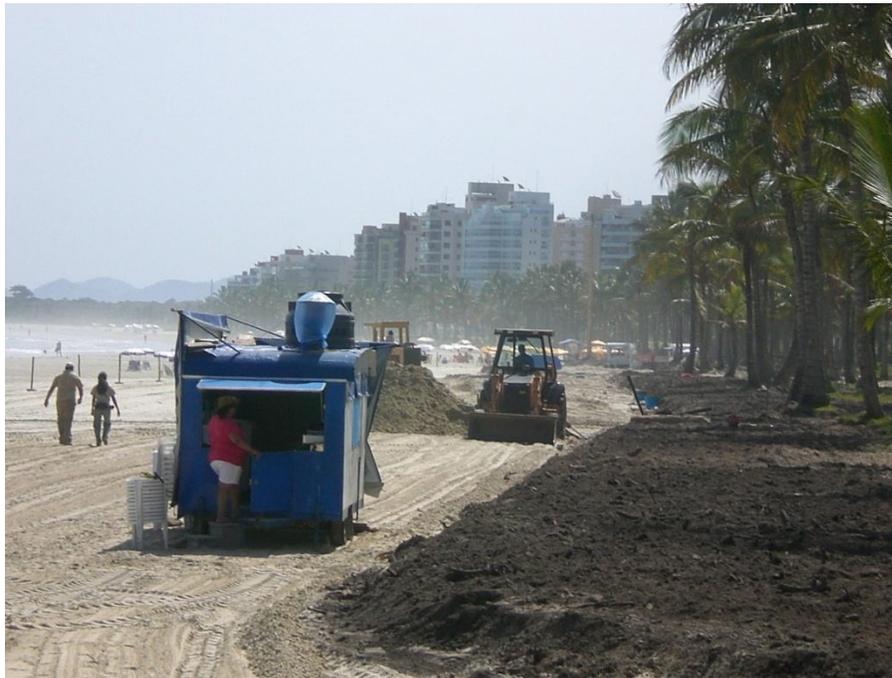
Figure 13: Preparation of land with the deposition of organic material.
Source: Luiz Lucena.

The first stage of the project, held by the Association of Friends of the Riviera de Sao Lourenco was the site preparation through the construction of the trench, palisades and deposition of organic material using heavy machinery such as hydraulic backhoe and bulldozers, as shown in Figure 13.

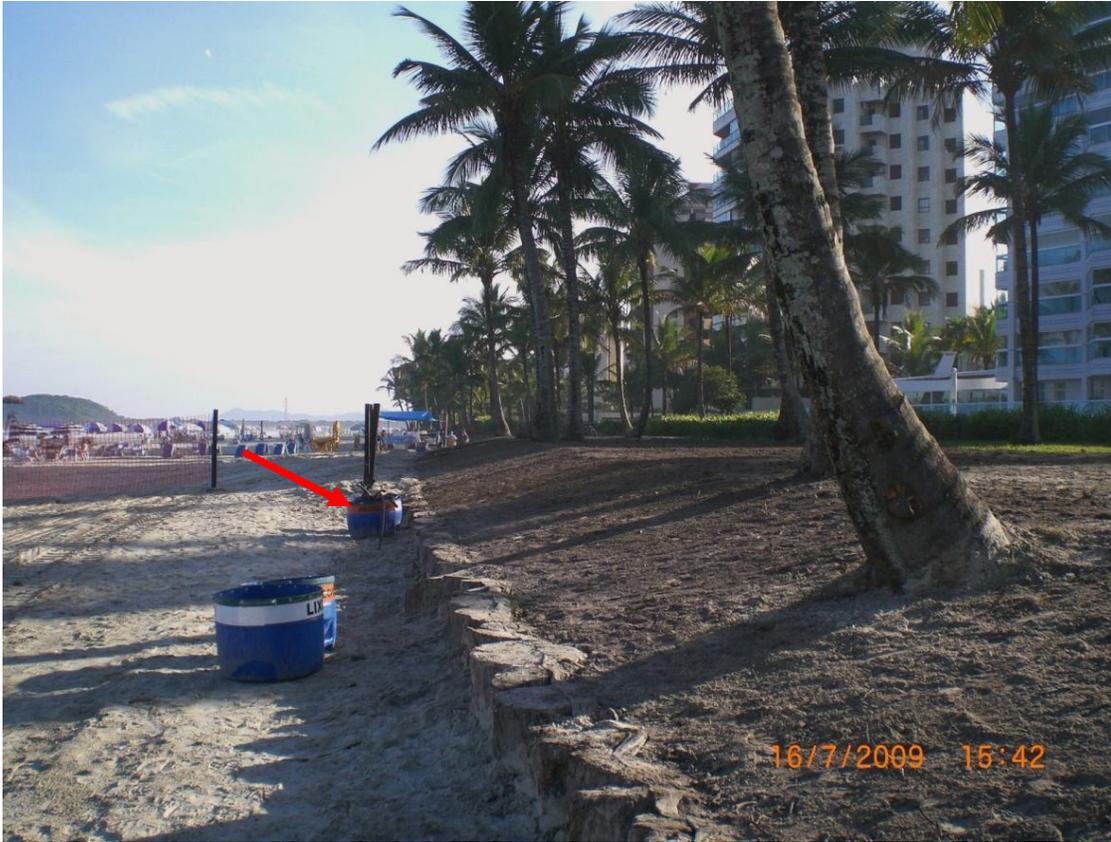
Figure 15: Detail: palisade and slope ready for erosion control blanket installation.
Source: Luiz Lucena

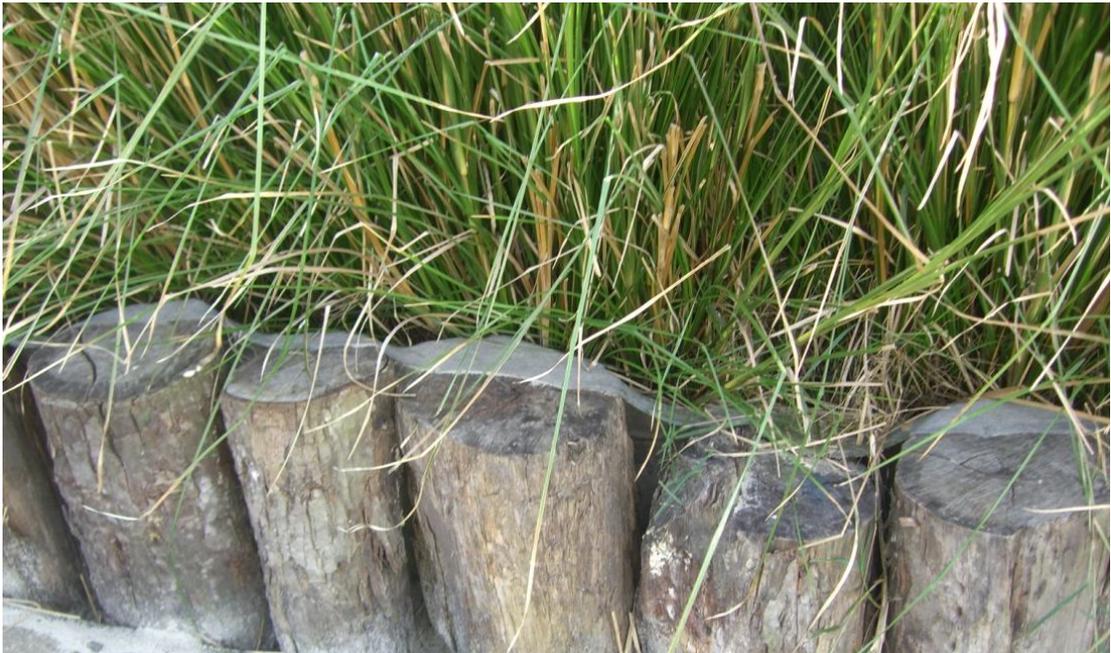
Figure 16: Detail: palisade, geotextile and Vetiver.
Source: Luiz Lucena

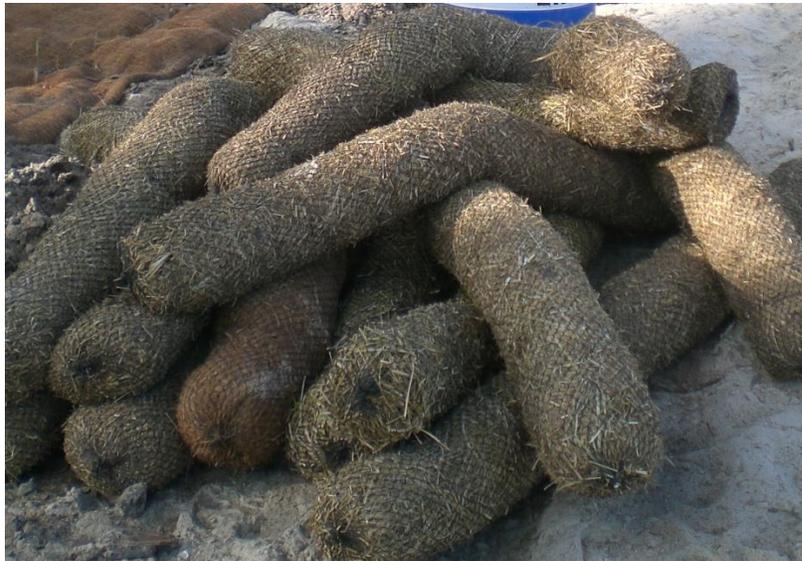
Figure 18: Sediment retainers 0,30 m diameter - Bermalonga ® D30
Source: Luiz Lucena

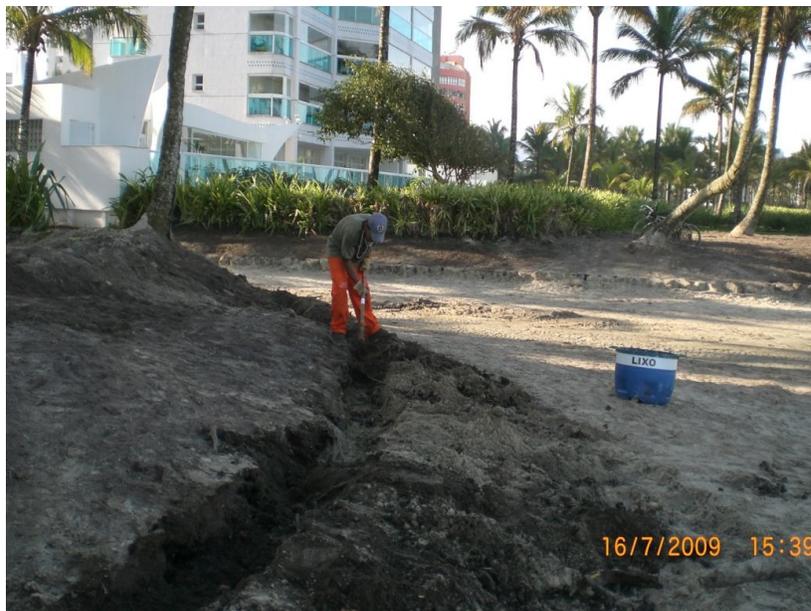
Figure: 19: Trench excavation for sediment retainer installation.
Source: Luiz Lucena

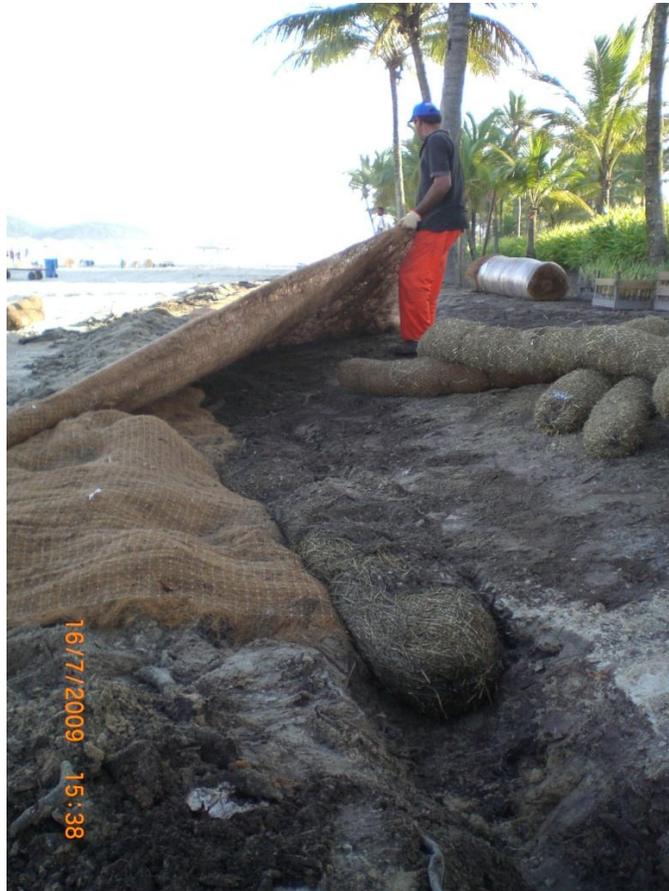
Figure: 20: Installation of erosion control blanket..
Source: Luiz Lucena

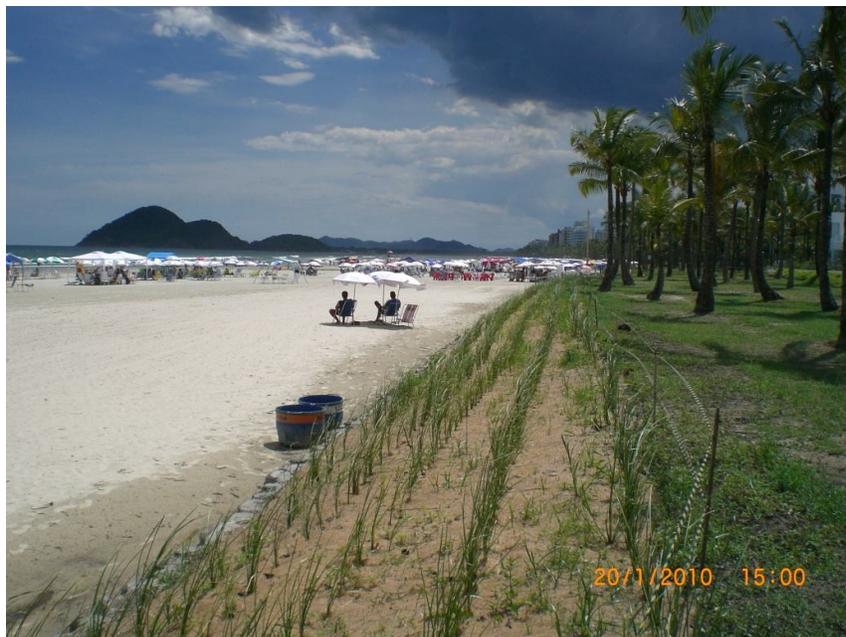
Figure: 21: Beginning of Vetiver development.
Source: Luiz Lucena

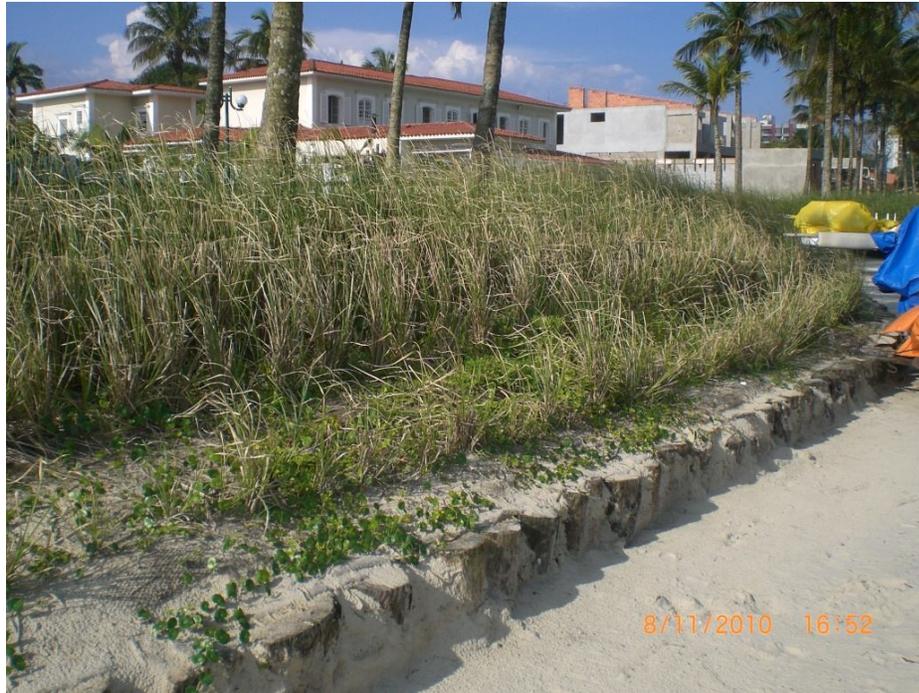
Figure: 23: First Vetiver hedgerow bent after strong surf and wave hit.
Source: Luiz Lucena

The highest tides in Brazilian coast occur usually during the months of August and September. In September 2009, there were some sea storm surge events, leading to strong surf and wave hitting the system just one month and fifteen days after completion of installation part one. The consequence of this natural phenomenon was that the first Vetiver hedgerow was bent and recovered without maintenance.

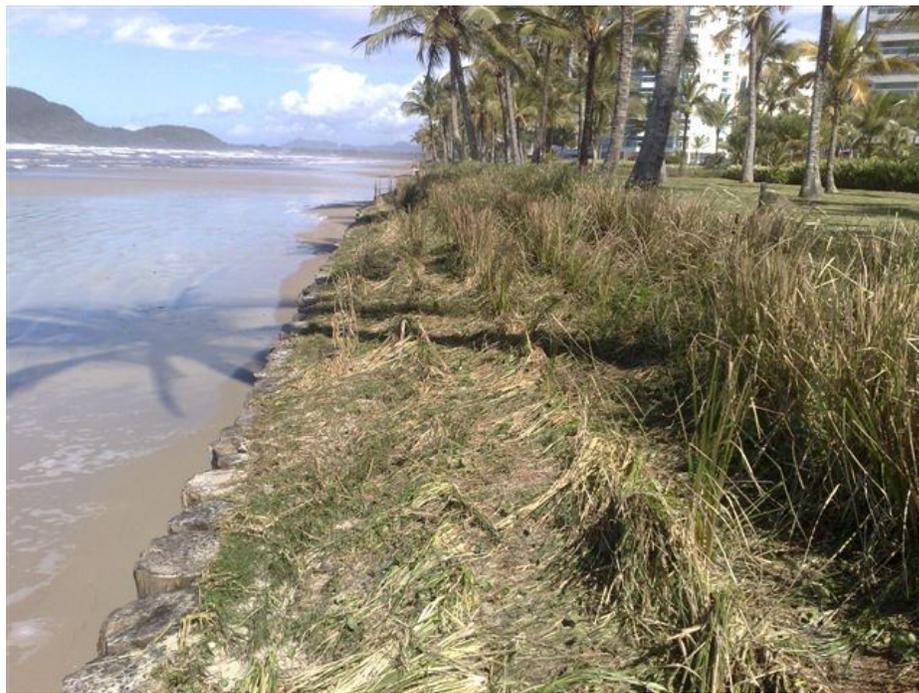
Figure: 24: First 3 Vetiver hedgerows at the worst spot where wave hit and no soil loss observed.
Source: Luiz Lucena
